# Greenland Fishery Building, Bridge St, King's Lynn, Norfolk

## Condition Report on the Wall Paintings

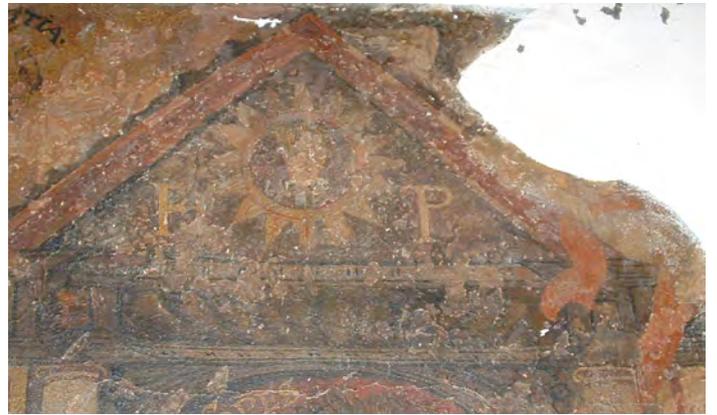
**Plate 6**

The support is brick with lime plaster. The plaster is generally adhering well to the brick. There is some localised movement associated with a diagonal crack through the middle of the scheme. The surface is pitted with keymarks for a later plaster. The plaster losses have been irregularly filled and the whole effect is ‘puddled’. More recent mechanical damage has occurred above the right pediment, perhaps caused by a ladder (? Plate 6).

*Above: detail of top right corner*

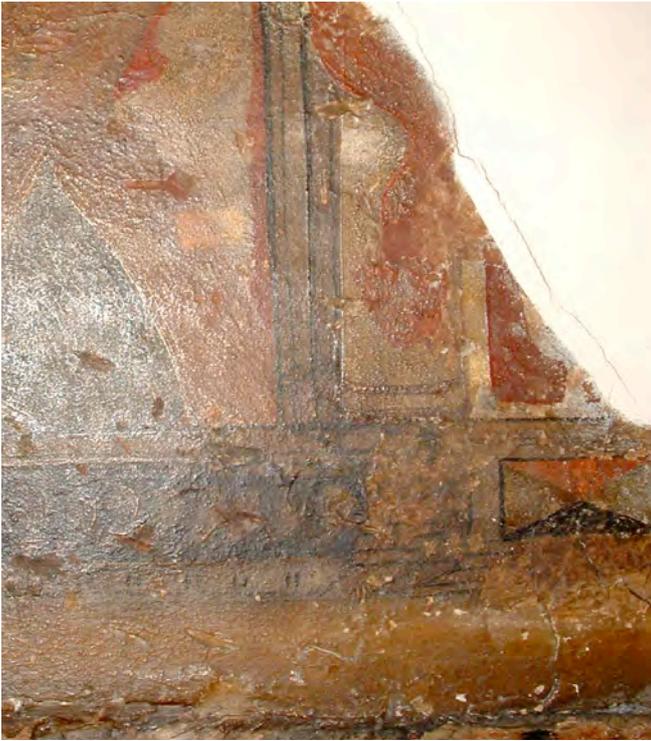
**Plate 7**

Localised areas of flaking and blistering occur on the sleeve of ‘Spes’, for instance, and in the bottom right corner (plates 7&8). Flecks of white show that there is flaking and loss elsewhere in the painting.

*Above:* detail of bottom right corner and cleaning tests

The essential work is to stabilise the paintings. This will include fixing all areas of flaking paint, securing detaching areas of plaster and filling cracks where necessary.

- An acrylic dispersion such as Plextol B500, or Primal AC33 diluted in water, to readhere flaking paint. The dilution will be established following tests on site.
- Detaching areas of plaster can be secured with a grout of lime putty and washed sieved sharp sand, injected behind the plaster.
- A mortar of lime putty and washed sieved sand to fill the cracks where necessary.

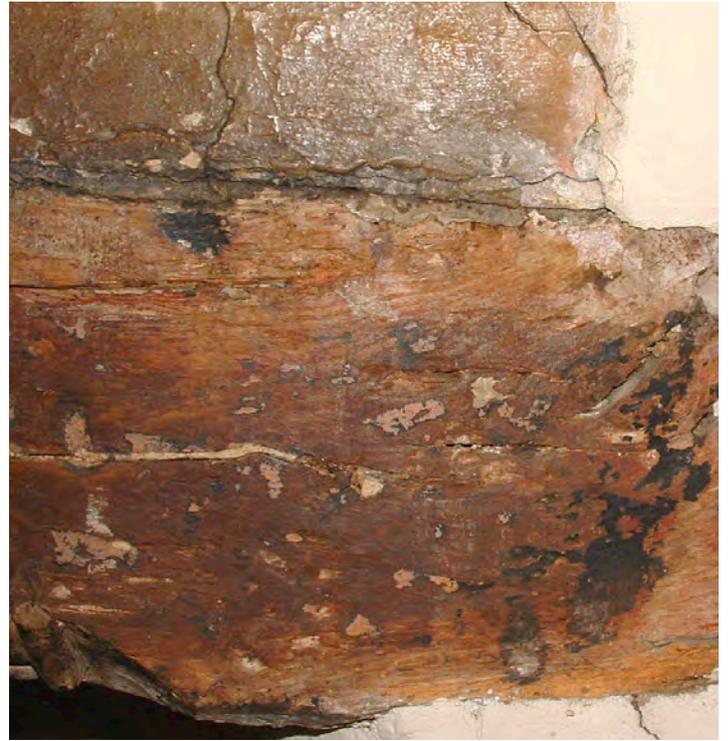
**Plate 8**

This had several different schemes including a dull, yellow/brown iron oxide; an undercoat of pure red iron oxide with a pure red lead top coat; a layer of limewash, or distemper tinted with yellow iron oxide; a black scheme of pure carbon black over a dark grey undercoat of carbon black and lead white; two coats of off-white or stone coloured oil paint, both of them based on mixtures of lead white and iron oxides.

*Above:* detail of chimney lintel

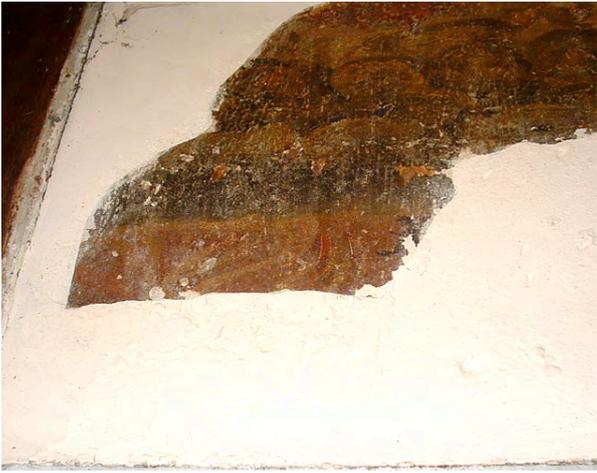
**Plate 11**

The worst areas of flaking and blistering can be seen on the top right of the devil painting on the return wall (plate 14) and the bottom left of ‘Dives’ over the door (plate 11)

*Above:* detail bottom left corner

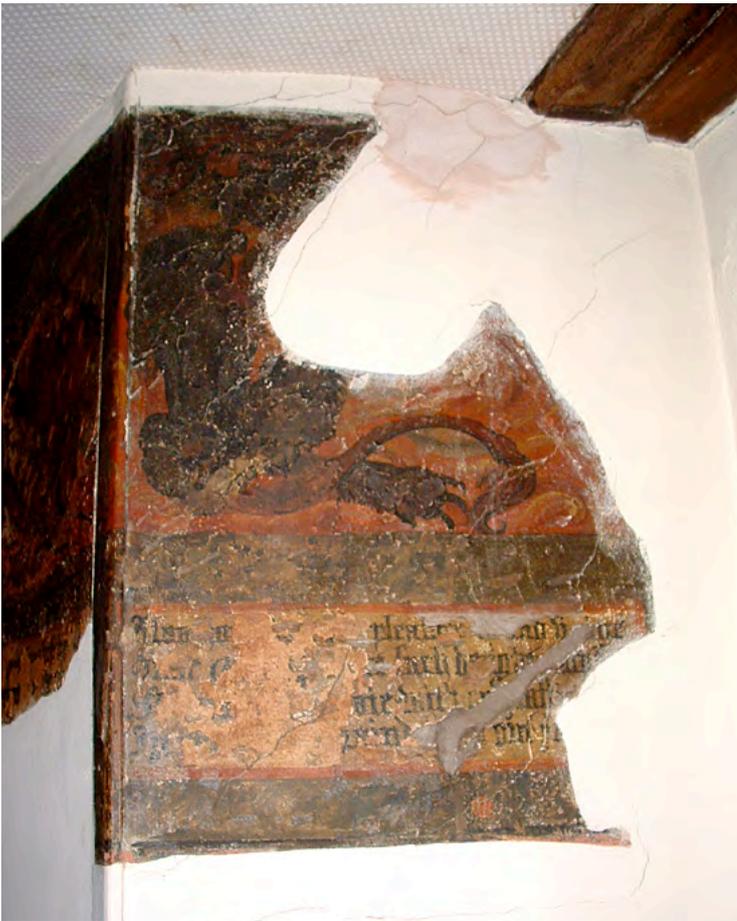
**Plate 13**

on the devil on the return wall (plates 13&14), and although the repairs are ‘unsightly’ they are, at present, stable. They will need monitoring during building work.

*Above:* view of a devil?

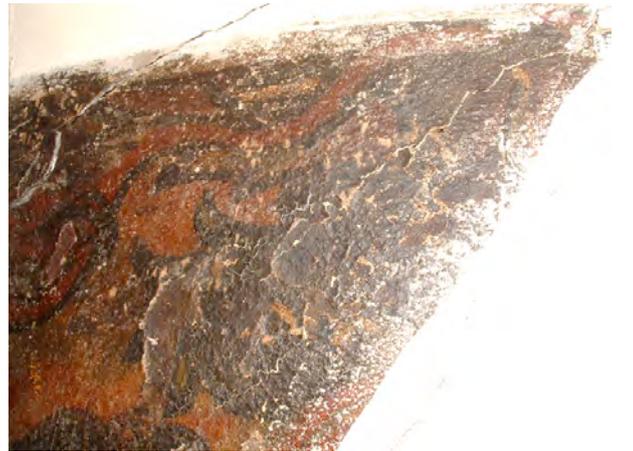
**Plate 14**

*Middle right:* detail of plate 13

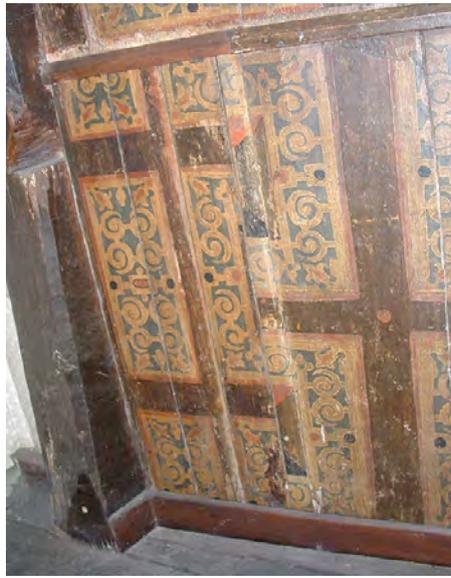
**Plate 19**

1612. Vanessa Parker suggests that the panelling was inserted c.1654 but the source of the information is unclear.<sup>7</sup> Sections of the panelling have clearly been rearranged – boards at the lower left side are out of order (plate 19), but the general arrangement of the texts and the surviving panelling fits around original architectural features. The similarity of the strapwork design on the panelling and the decoration on the attic floor above might suggest that they were carried out at the same time. The analysis shows a number of similarities in technique and pigments between the panelling, the subject paintings and the strapwork which suggests that they were conceived as an ensemble. Differences in technique can probably be ascribed to a different hand. The subject paintings are technically sophisticated, using pigments mixtures and an expensive range of pigments. The panelling technically is much simpler but it is repetitive decorative work and uses, for instance, a cheaper blue, indigo instead of the more expensive azurite on the subject paintings. The initials JA indicate that the work was carried out for John Atkins who died in 1617. If this interpretation proves to be correct,<sup>8</sup> then the schemes can be quite tightly dated to 1612; this would also date the building alterations.

The panelling has clearly been arranged, evidenced by the mismatched panels at the left side. Some of the panels are slightly loose and early repairs include a board, dated 1676. This board appears to retain a decorative scheme under the overpaint.

*Middle: detail of panelling*

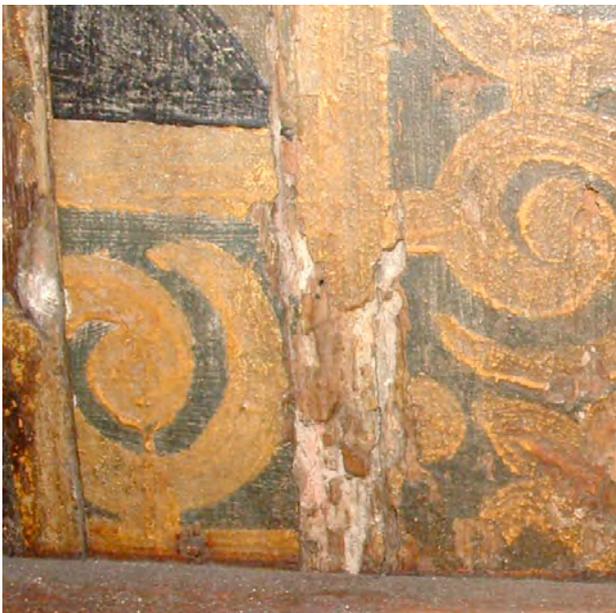
**Plate 21**

Old worm damage can be seen at the bottom edge, partially behind modern skirting. Localised blistering paint occurs in this area. Otherwise, the paint is generally stable but has suffered from mechanical damage in the past. As with the other schemes, the whole surface is covered by dirty, discoloured surface coatings.

*Left: detail of damaged painted timber  
(All photos © A Kirkham 2006)*

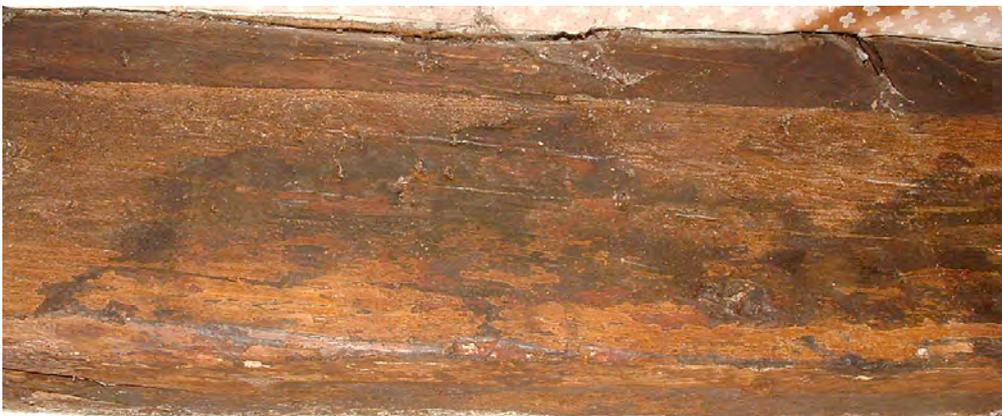
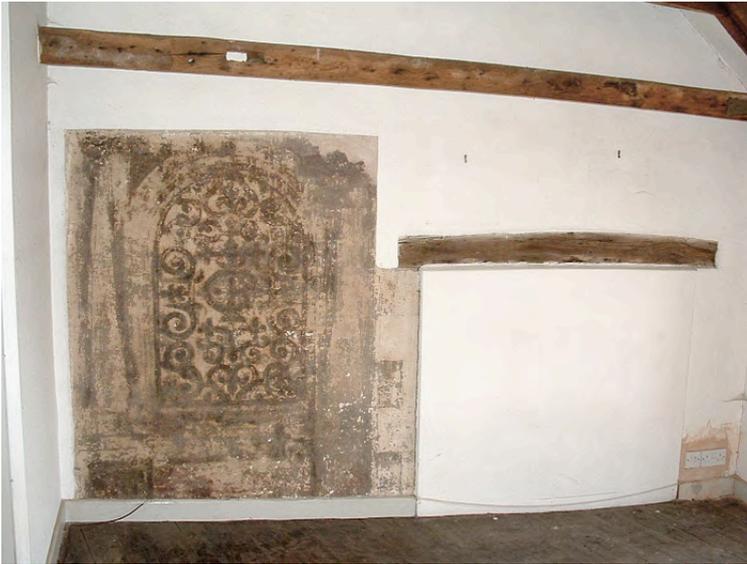
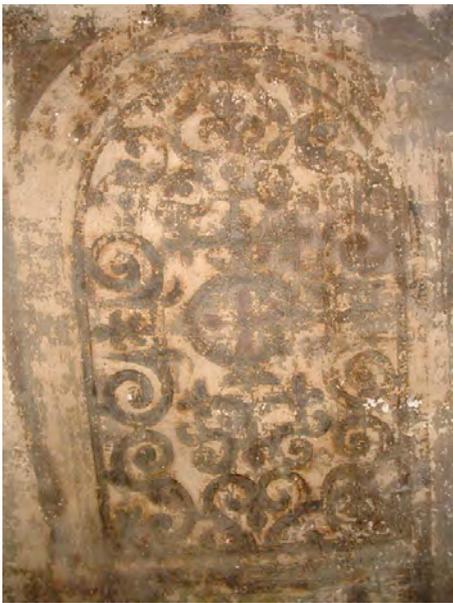
One of the most immediate problems is visibility. The surface coatings on all the paintings have darkened and discoloured so much that it is extremely difficult to read them. Furthermore, the original colour is distorted by the discoloured surface coatings so that ‘Spes’ dress, for example, appears green but is, in fact, blue. Cleaning tests show that the paintings would be transformed if cleaned and their ‘readability’ improved immeasurably. Closer inspection shows that there are additional problems associated with the coatings which are of more immediate concern. Flaking is evident on Dives and Lazarus, the overmantel and the strapwork scheme. With ‘Dives’ and the overmantel, the problem is localised; the strapwork scheme, however, is in worse condition with flaking across the painting, as evidenced by the small white areas of loss (plates 28&29).

This painting was clearly in the worst condition in the 1950s and it is the one which is most unstable now. The problem is the surface coating which is flaking and pulling the paint away at the same time. There is clear evidence of loss across the painting (plates 27-29). However, removing or thinning the coating will be problematic because the paint and plaster surface was in such poor condition when the coatings were applied.

*Left: view of the painting and blocked fireplace*

*Middle left: view of the strapwork decoration*

*Middle right: detail of plate 28*

Although not essential now, it may become necessary to remove the surface coatings if the rate of flaking increases. It would be worth considering cleaning the paintings, especially those on the first floor. Cleaning needs to be carried out in two processes, the first to remove the wax coating the second to remove the varnish coating. The results would be spectacular. It may, however, not be possible to remove the surface coatings from the strapwork scheme and further tests are required to establish, if possible, appropriate methods and materials for removing/thinning the surface coating in this area.

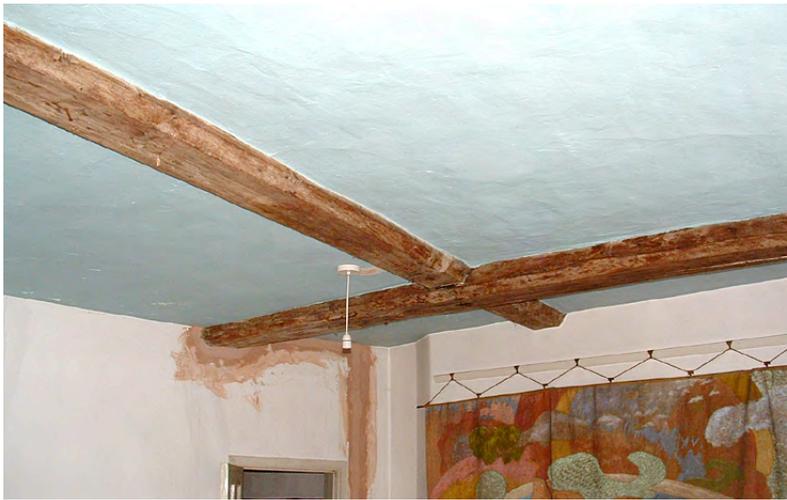
**Plate 31**

- Exposed timbers in the ground floor room below the painted room retain evidence to show that they were painted red at least twice (plate 31). Other timbers on the ground floor retain traces of red. These will be C17th decoration and must not be stripped.
- The mullions of the stair window were painted with white limewashes or distempers, the saddlebars were painted red (plates 32-33). This was probably a common treatment but the evidence rarely survives. The window must not be stripped.
- The fireplace at the north end of the attic floor retains ruddle on the brickwork and imitation ashlar quoins, at present covered with household paints (plates 34-35).

*Left: view of the painted ceiling timbers, ground floor room  
(Photo © A Kirkham 2006)*

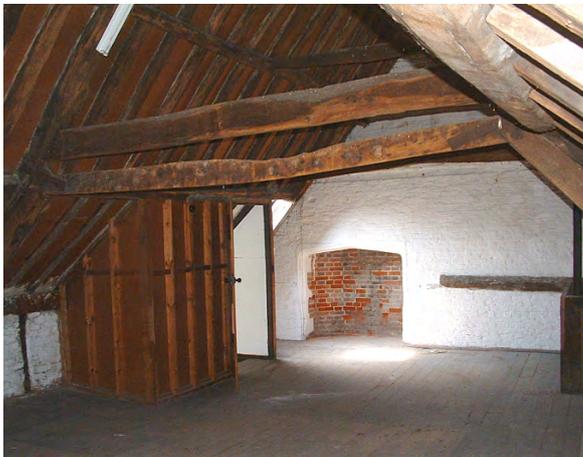
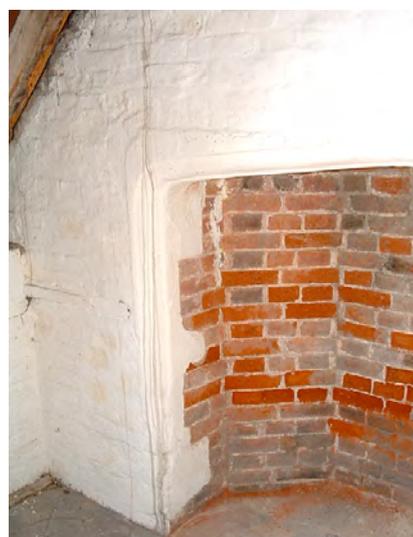
*Far left: view of the attic floor, north end of the building*

*Left: detail of the fire-place*
